Manhole Inspection Summary

Manhole # S21C__035MH

Location Address: **1808 ALLEY-LAURETTA-FRANKLIN** Cross Street: **KIRBY LANE**

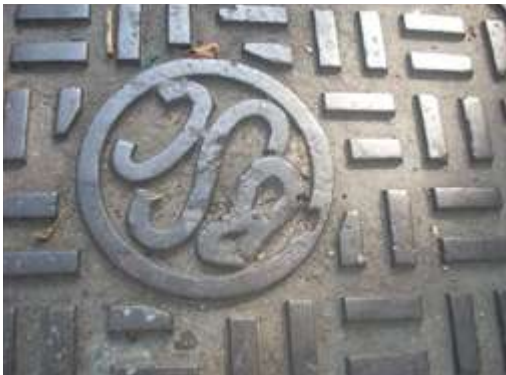
Defect 5

Cover Shape: **Circular** Diameter: **24** (in.) Length: (in.) Dist A/B Grade: **0** (in.)
Type: **Sanitary** Condition: **Worn** Cover Material: **Cast Iron**
Properties: ☐ Bolted ☐ Vented ☐ Water Tight ☐ Water Tight Insert

WORN COVER

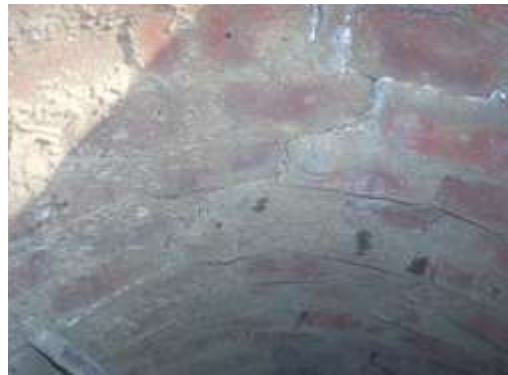
Defect 4

Corbel Material: **Brick** ☐ Parged Type: **Concentric/Eccentric**
Condition: ☐ Sound ☒ **Cracked** ☐ Root Intrusion ☐ Loose Brick ☐ Deteriorated
Infiltration: ☒ None ☐ Joint ☐ Cracks ☐ Mortar ☐ Roots ☐ Wall

CRACKED CORBEL

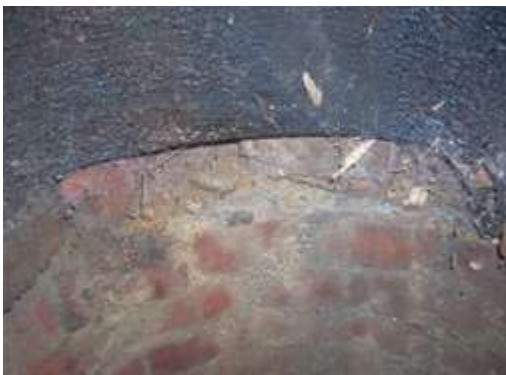
Defect 3

Chimney / Frame Adjustment ☒ Exists Material: **Brick** ☐ Parged Height: **3** (in.)
Condition: ☐ Sound ☐ Cracked ☐ Root Intrusion ☒ **Loose Brick** ☒ **Deteriorated**
Infiltration: ☒ None ☐ Joint ☐ Cracks ☐ Mortar ☐ Roots ☐ Wall

DETERIORATED CHIMNEY

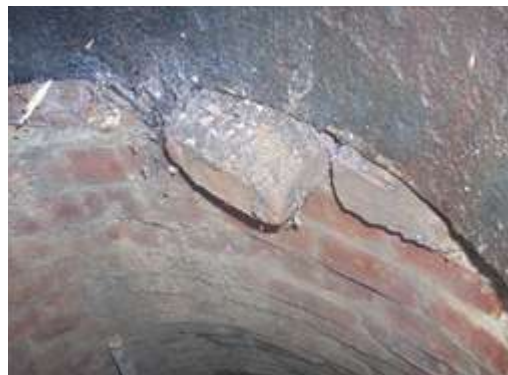
Defect 2

LOOSE BRICKS

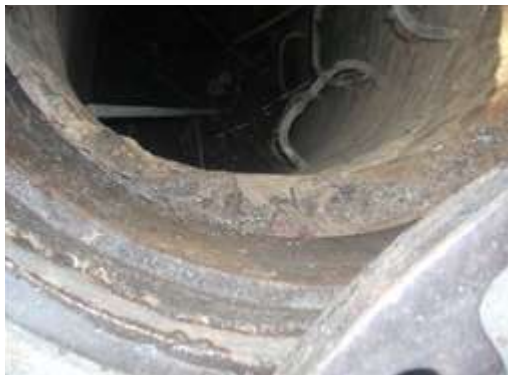
Defect 1

Frame Offset: **2** (in.) Condition: ☒ Sound ☐ Cracked ☐ Leaks

FRAME OFFSET

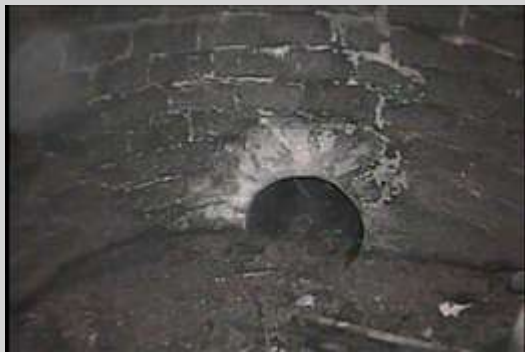
12 O'Clock Outflow

8 in. Circular Gravity Sewer
Pipe Out @ 12 O'Clock

Infiltration: **None** Pipe Seal Cond: **Sound**
